Hardening Communications Infrastructure to Reduce MTR's and Improve Reliability

Oct 19, 2017

Ted Villemaire

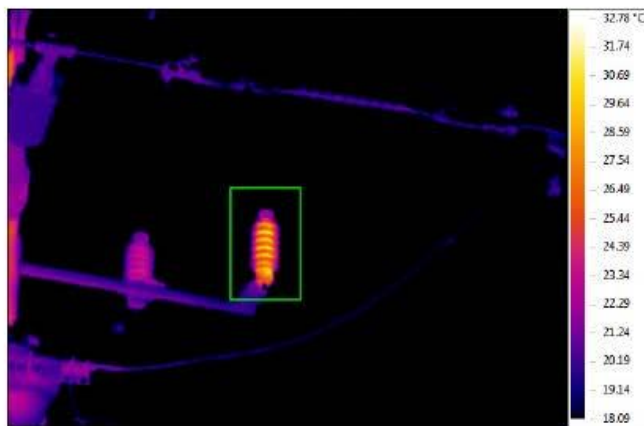
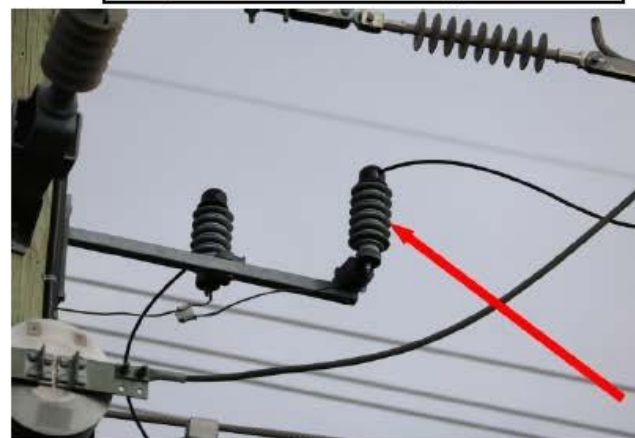
- Survey_Arrestors

Inspection#: 14	Prob#: 3
Prob Date&Time: 09/30/2016 15:52	
Indirect Temp.Measurement: Yes	
Component Temp.: 26.6@N/A	
Reference Temp.: 21.7@N/A	
Temp.Rise: 5.0@N/A

Description: Bottom phase surge arrester

Probable Cause: Leakage current - varistor column deterioration

Recommendation: Monitor for temperature rise

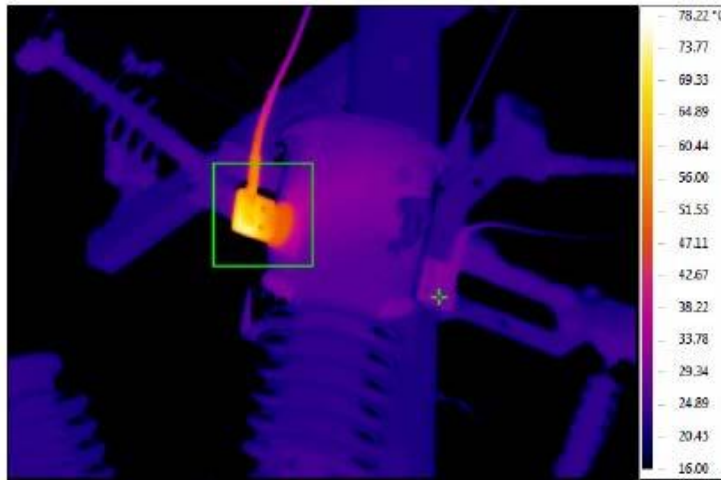
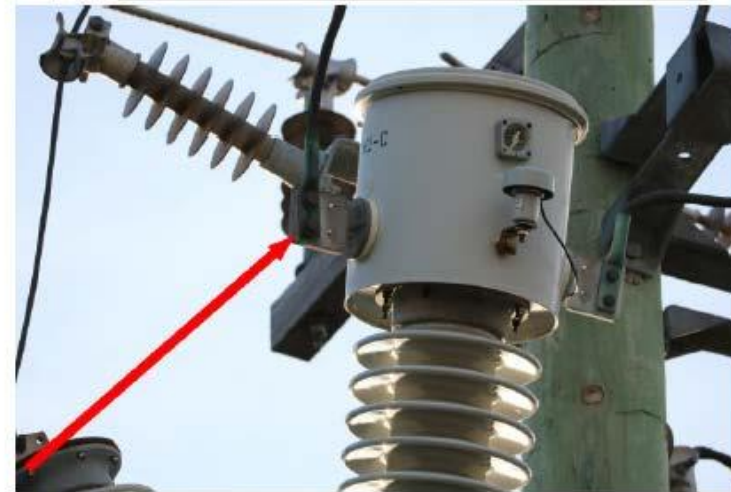
Paddle Connection

Inspection#: 18	Prob#: 1
Prob Date&Time:	09/27/2016 17:24
Indirect Temp.Measurement:	No
Component Temp.:	73.3@N/A
Reference Temp.:	24.7@N/A
Temp.Rise:	48.7@N/A

Description: Roadside (Blue) phase lug bolted connection at H2-C paddle

Probable Cause: High-resistance bolted connection. Significant oxidation on lug.

Recommendation: Clean/remake bolted connections on paddle

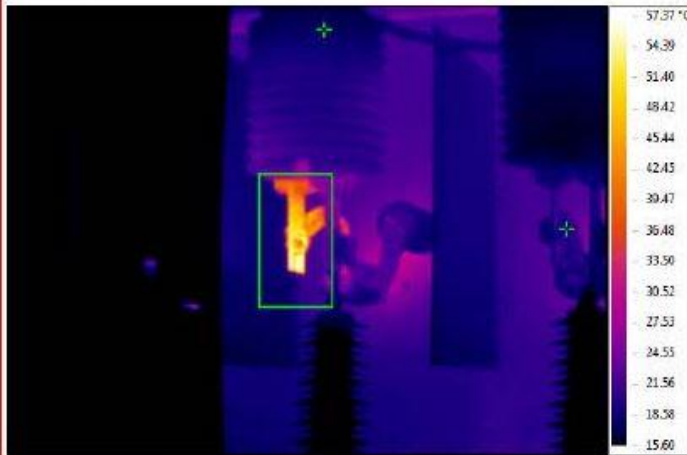
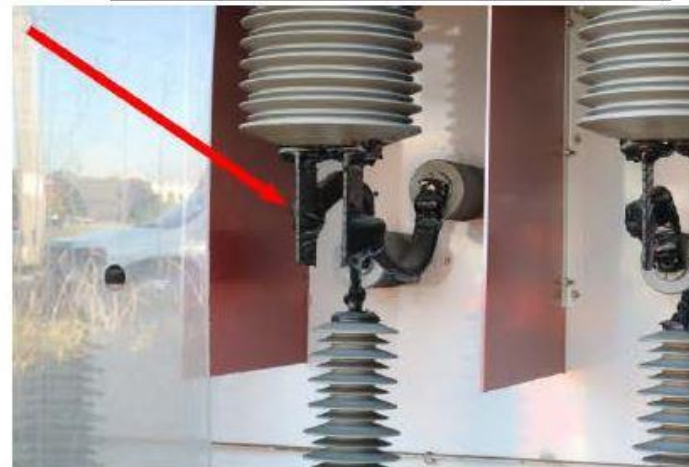
Loose Connection

Inspection#: 12	Prob#: 2
Prob Date&Time:	10/12/2016 11:18
Indirect Temp.Measurement:	No
Component Temp.:	55.5@N/A
Reference Temp.:	19.5@N/A
Temp.Rise:	36.0@N/A

Description: White phase CT, lug connection at H2 paddle

Probable Cause: High-resistance bolted connection

Recommendation: Remake bolted connections to paddle

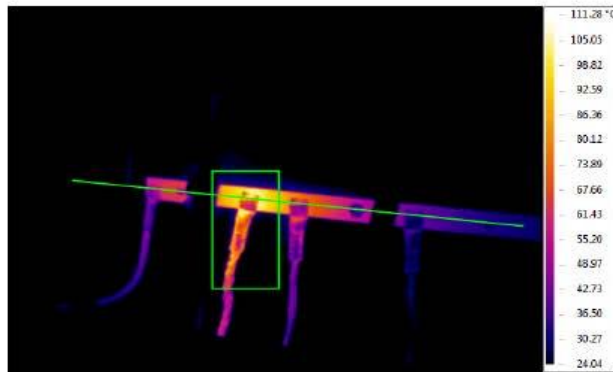
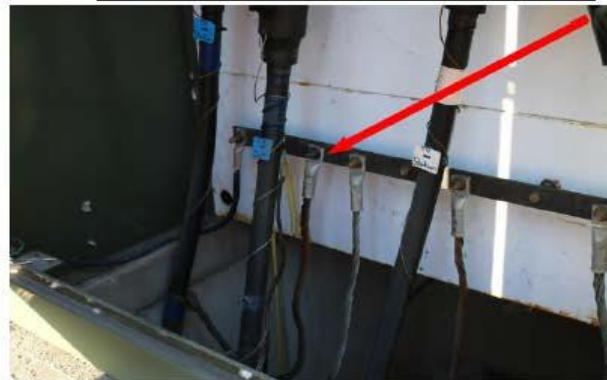
Ground Bus Hot

Inspection#: 12	Prob#: 1
Prob Date&Time: 10/12/2016 10:59	
Indirect Temp.Measurement: No	
Component Temp.: 105.3@N/A	
Reference Temp.: 20.1@N/A	
Temp.Rise: 85.1@N/A

Description: Blue phase conductor ground lug bolted connection at ground bar

Probable Cause: High-resistance ground connection. High bleeder current.

Recommendation: Remake ground connections. Check ground currents.

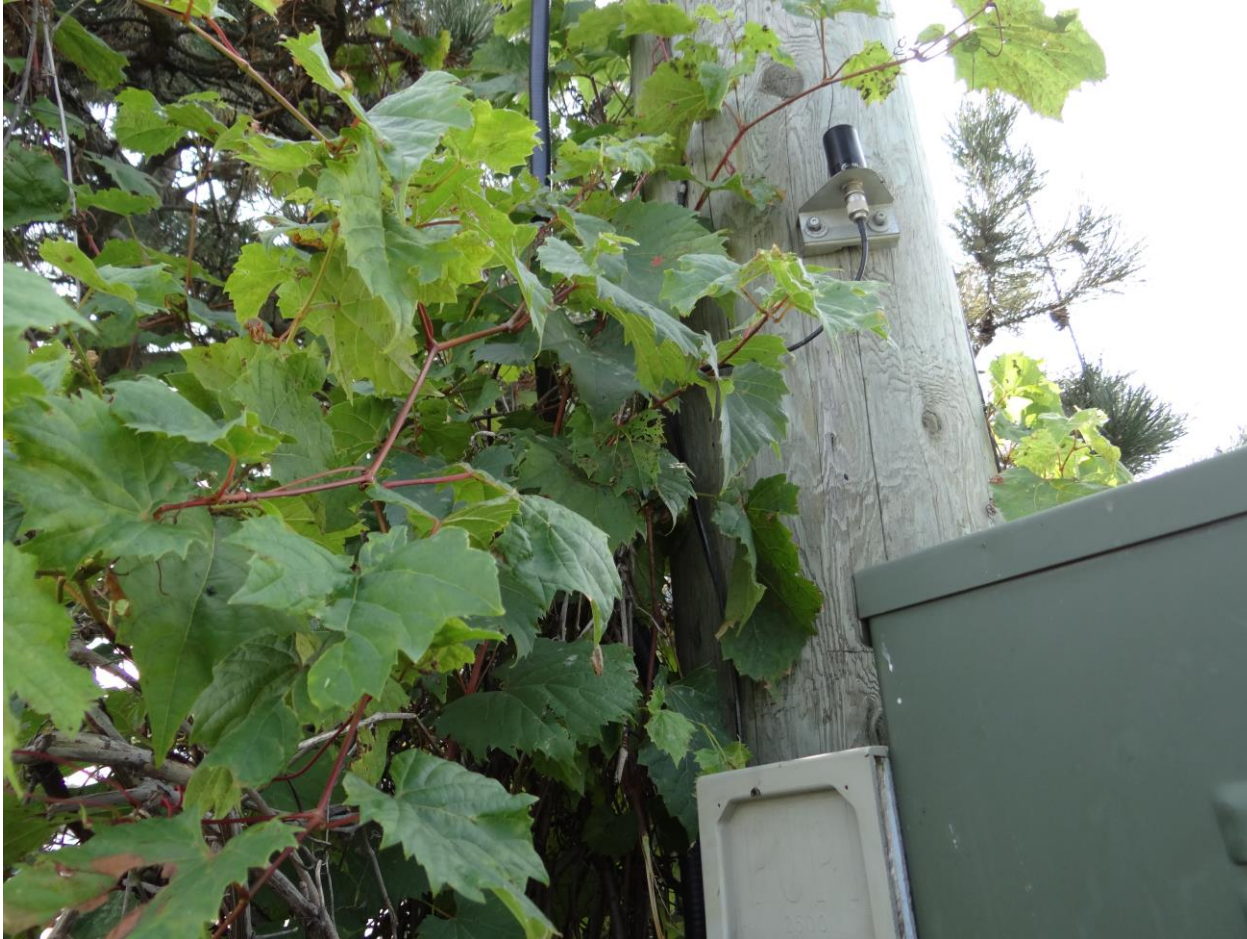
Vines

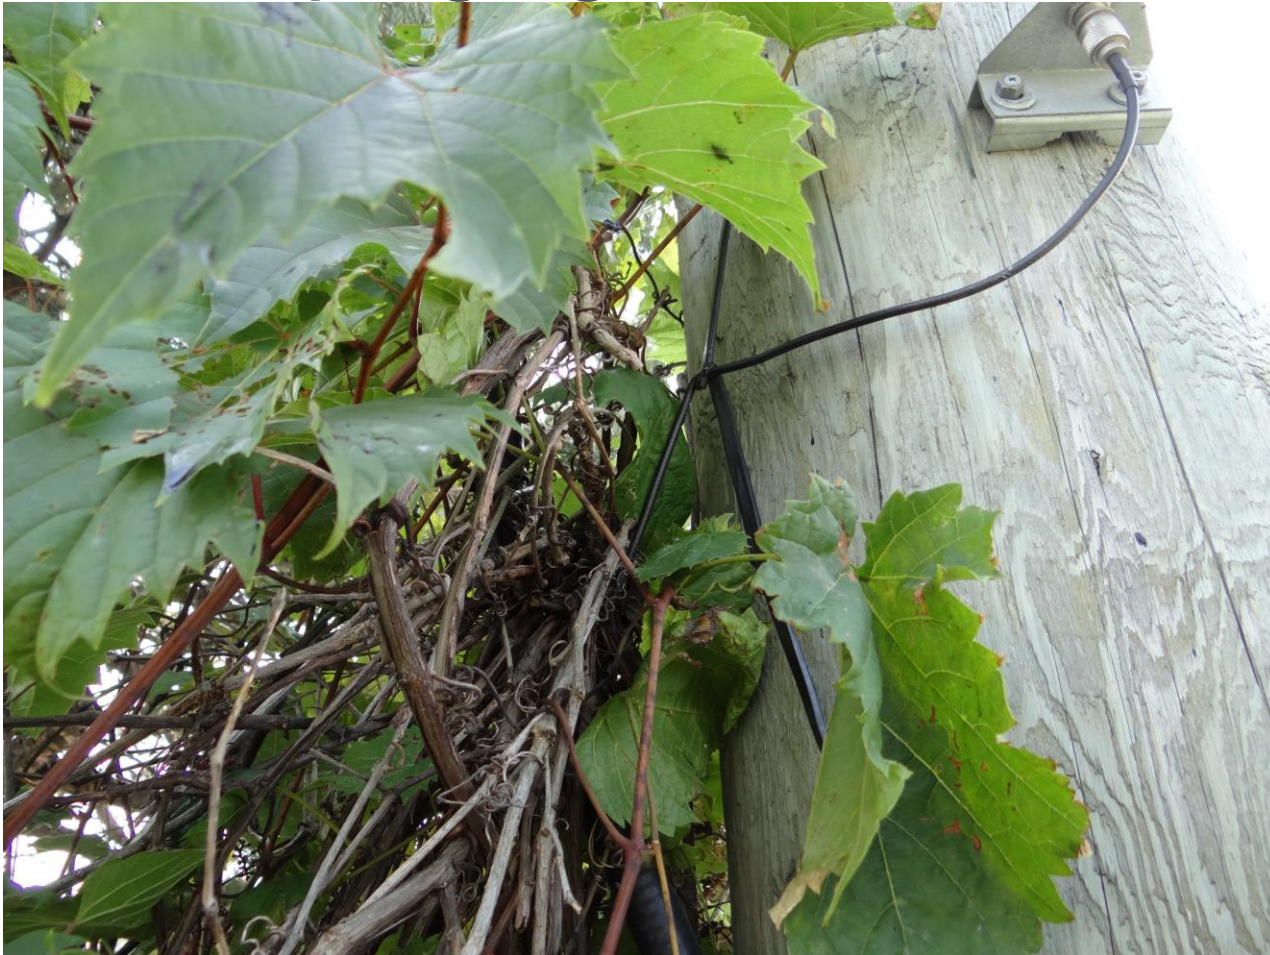
Vines Impinging on Antenna Cable

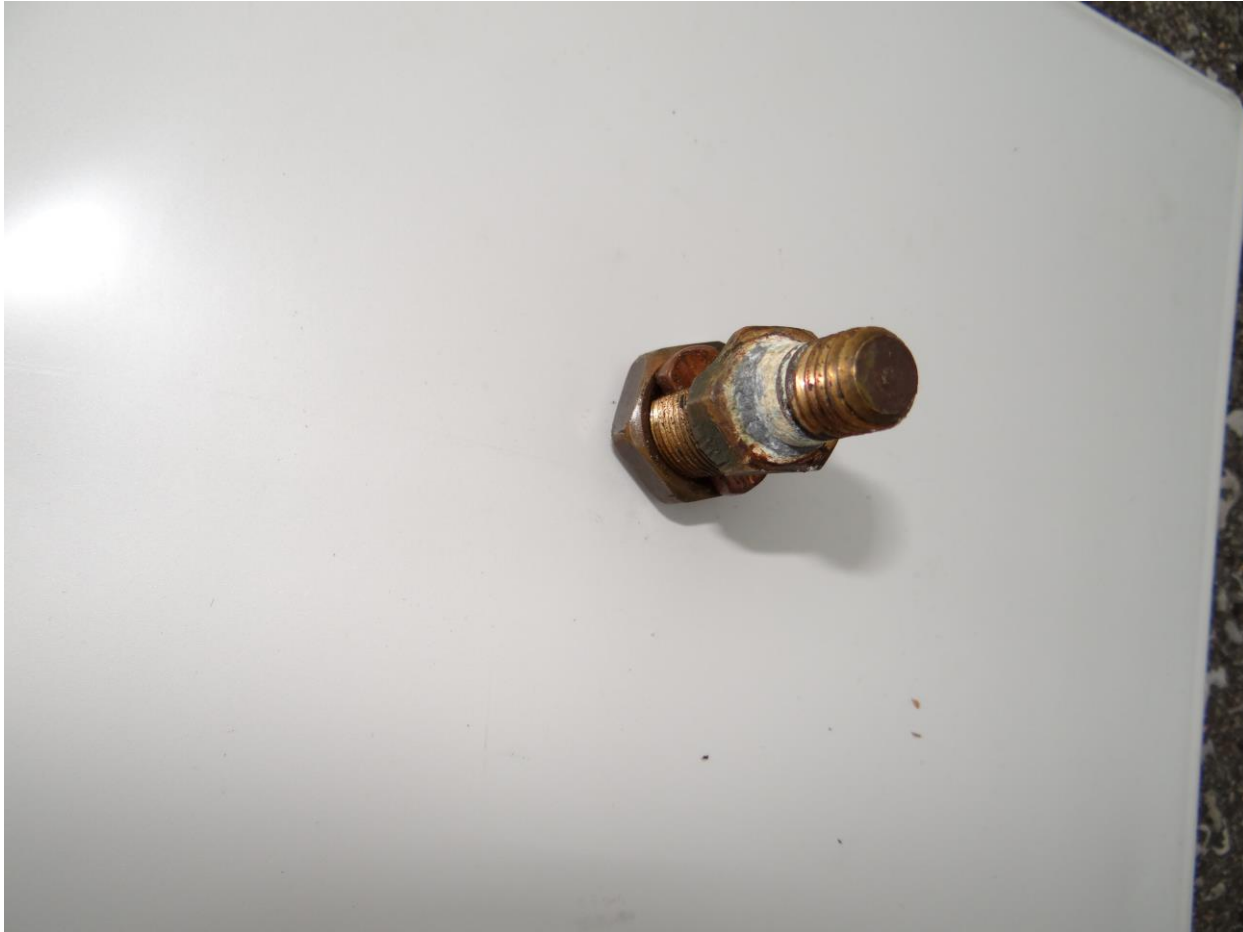
Oxidation-Lug Bolt

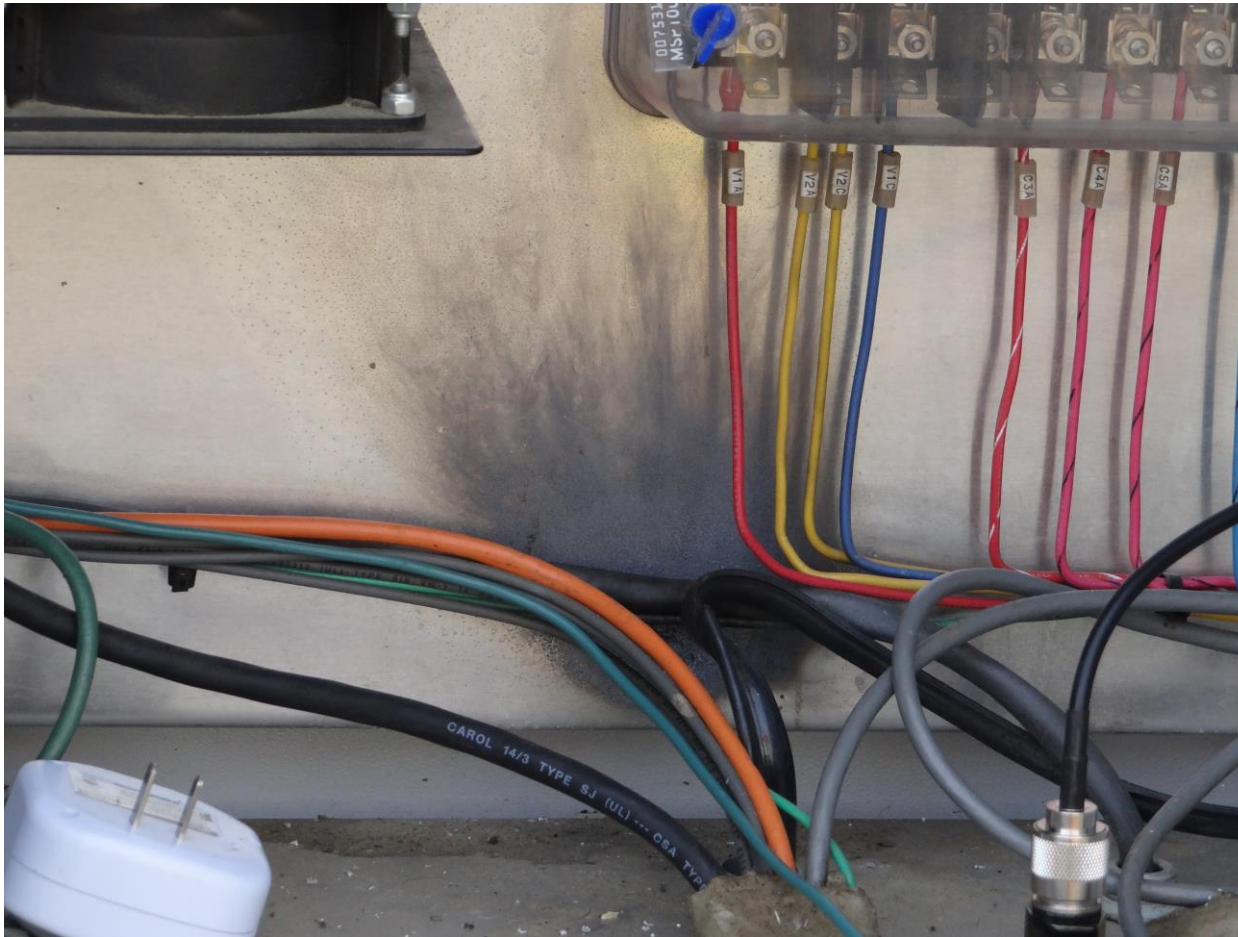
Ground Lug Burn Off

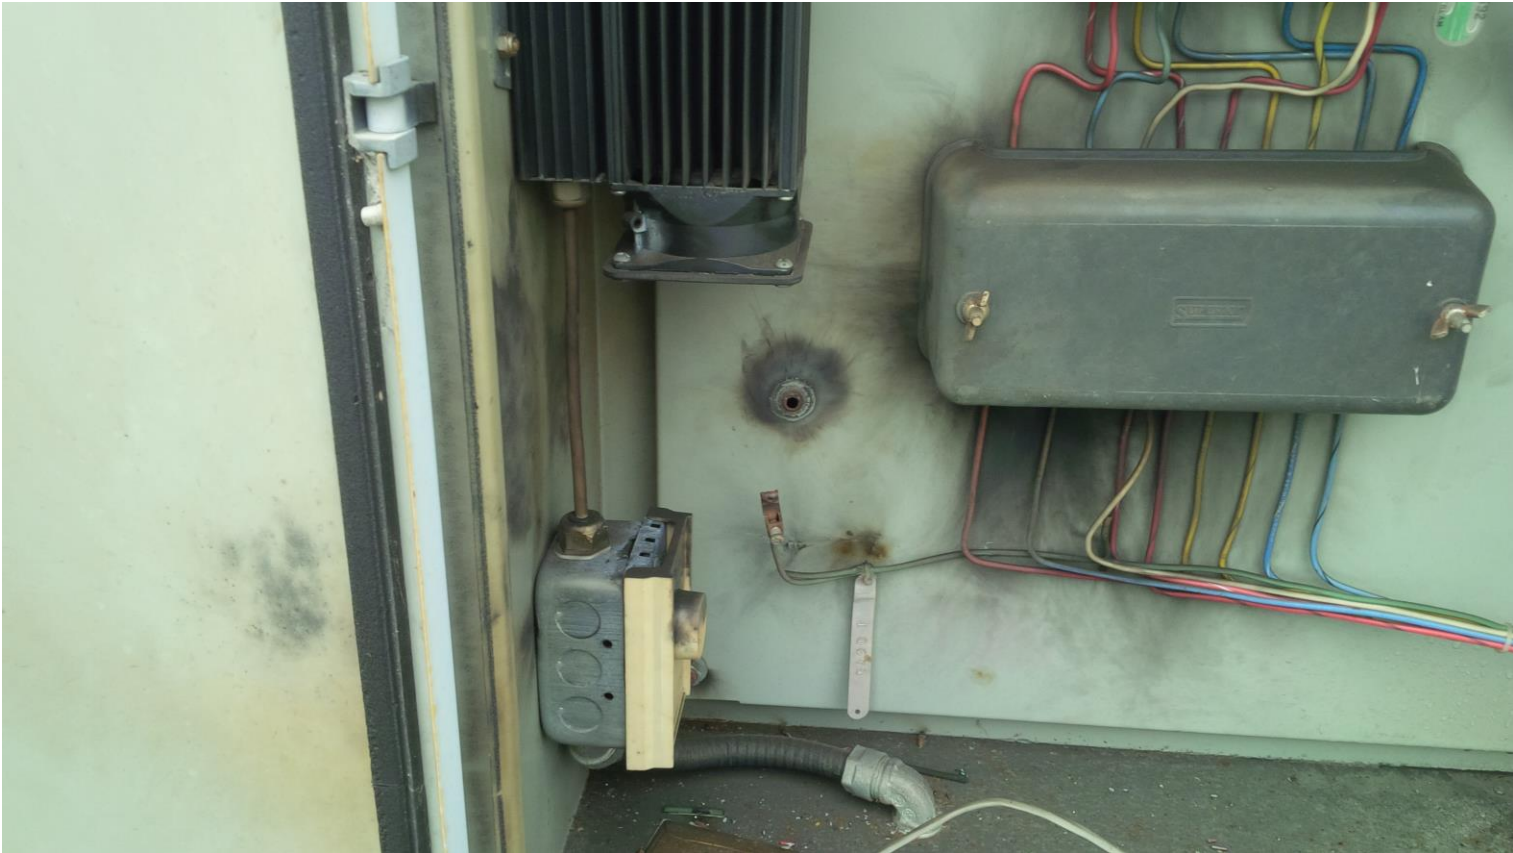
PT Failure

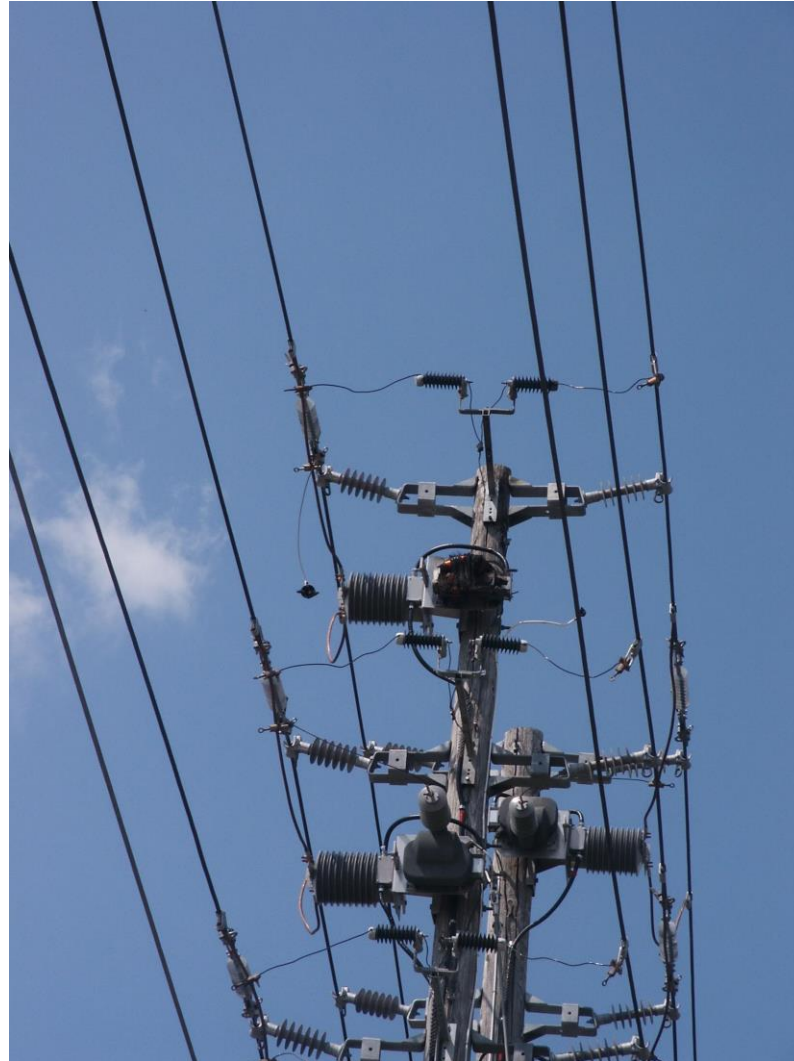
CTPT Failure

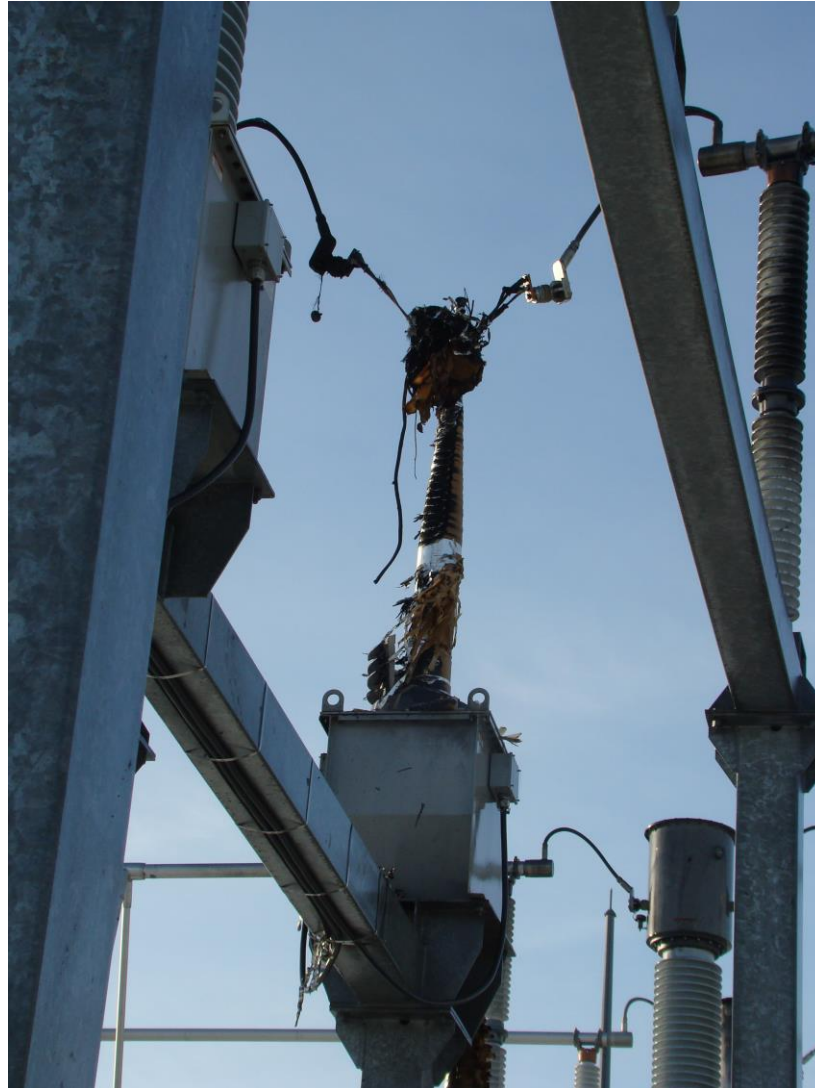
CT Terminal Flash

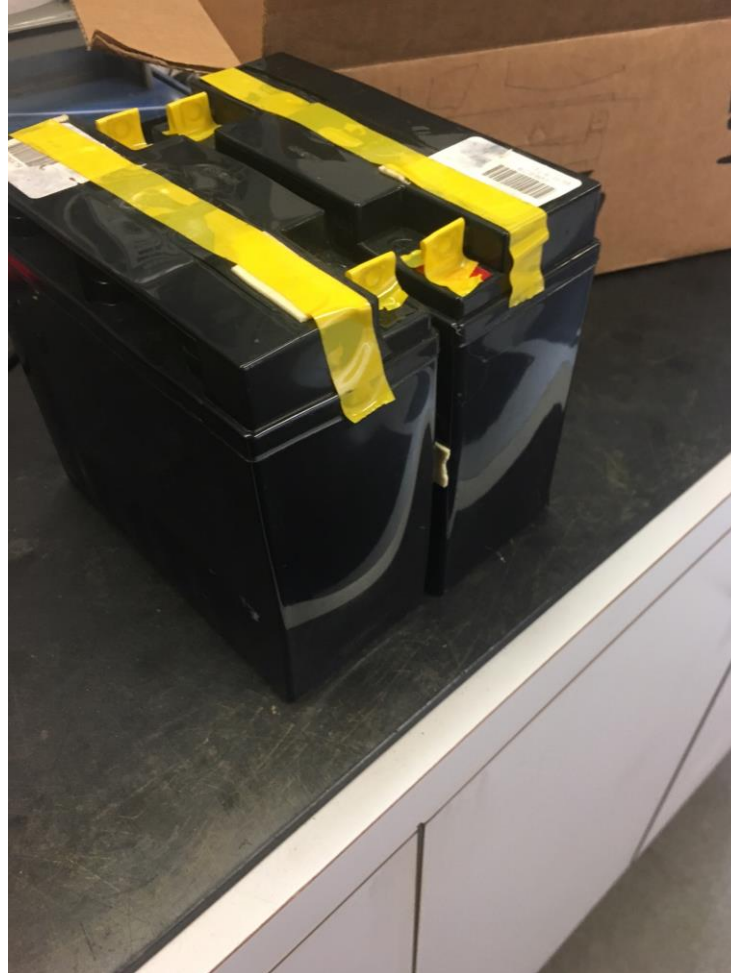
Heat - Damage

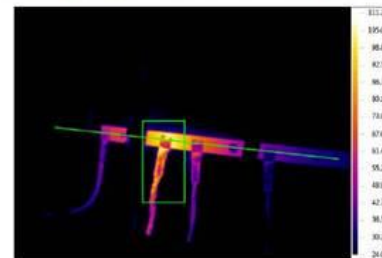
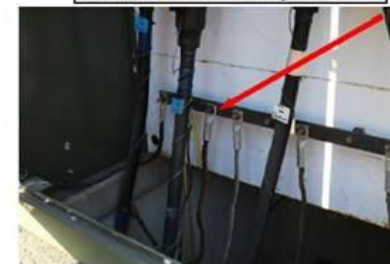
Inspection#: 12	Prob#: 1
Prob Date&Time: 10/12/2016 10:59	
Indirect Temp.Measurement: No	
Component Temp.: 105.3@N/A	
Reference Temp.: 20.1@N/A	
Temp.Rise: 85.1@N/A

Description: Blue phase conductor ground lug bolted connection at ground bar

Probable Cause: High-resistance ground connection. High bleeder current.

Recommendation: Remake ground connections. Check ground currents.
