# Using ION Meters as an Asset Management Tool.

Power Logic User's Group Meeting  
October 18, 2013  
Toronto Ontario, Canada

Presented by: Gary MacLeod,  
Project Manager, Power Quality Enhancement Program

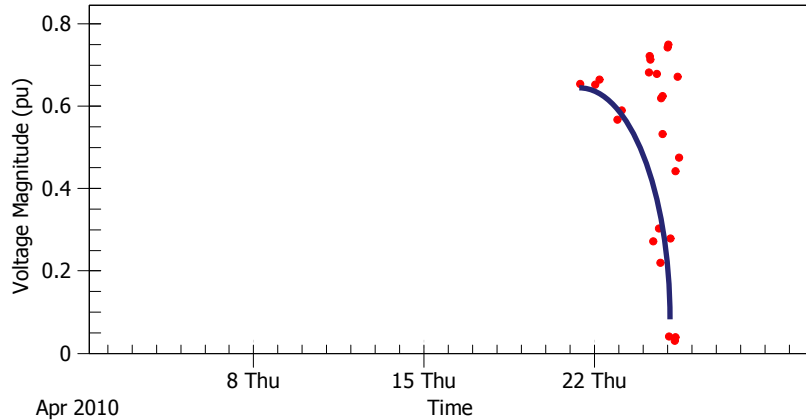
RMS Variation Magnitude Time Scatter Plot  
Transformer 1

# Transformer 1 RMS Variations and Damage

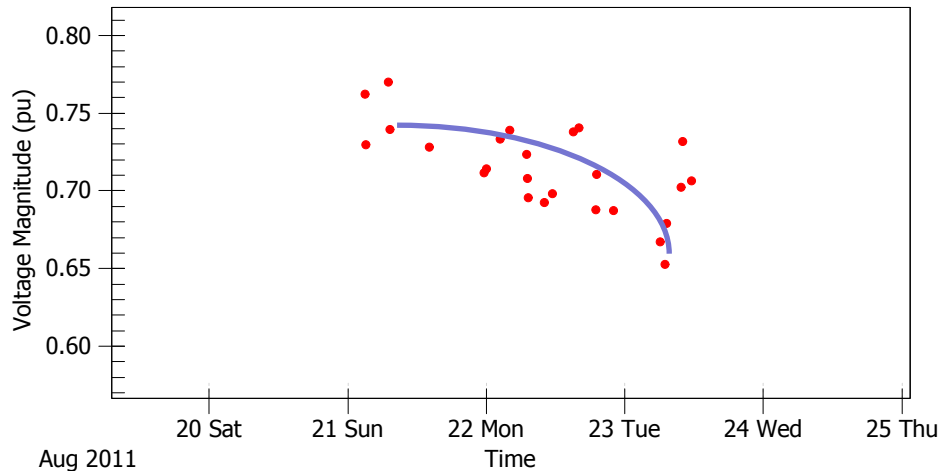
RMS Variation Magnitude Time Scatter Plot  
Transformer 2

# Transformer 2 RMS Variations

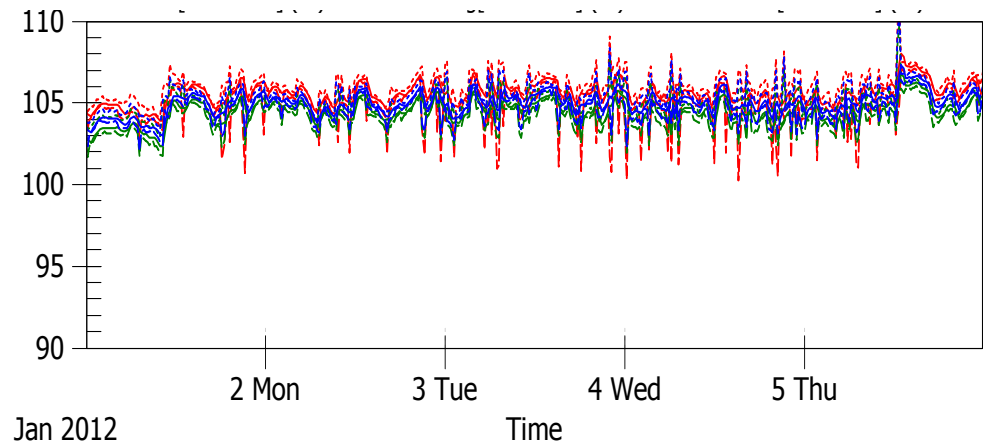
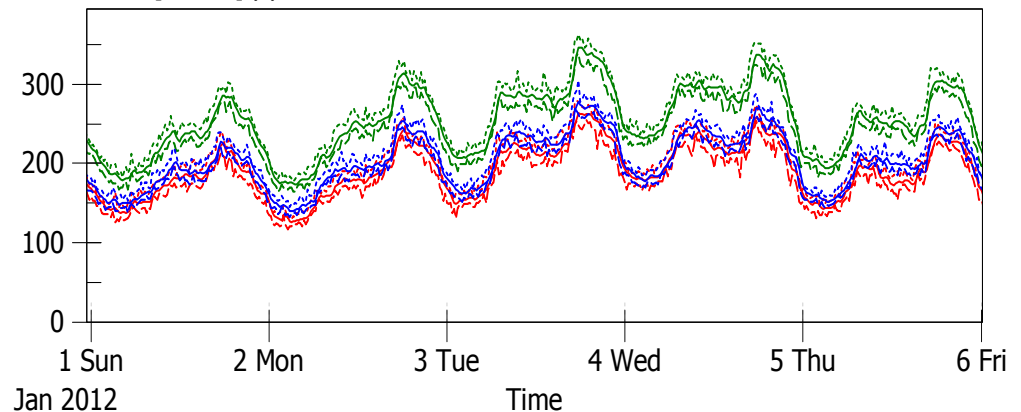
# Transformer 3 “No Events”

- There were no waveshape events recorded during this period.
- Voltage Trend data showed a frequent number of red phase minimum values that were not associated with current inrush or faults.
- Transformer was taken out of service and inspected and damage was found.

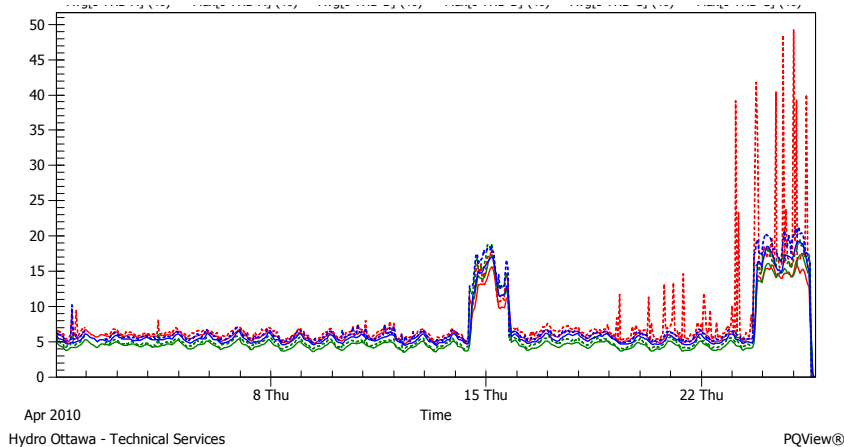
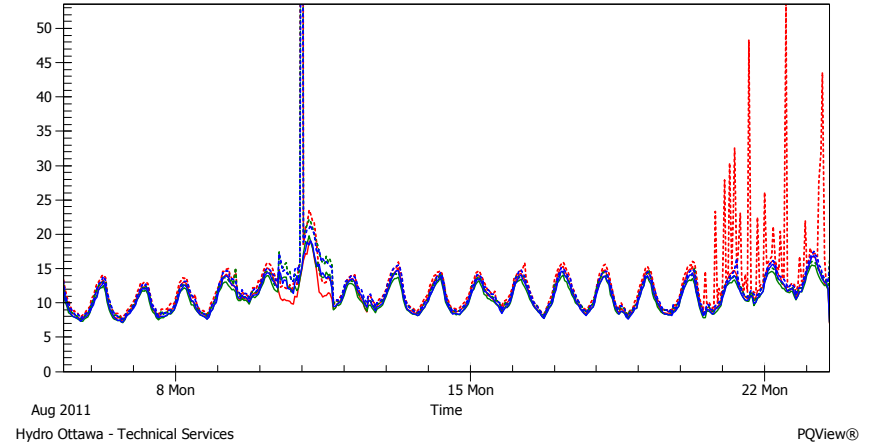
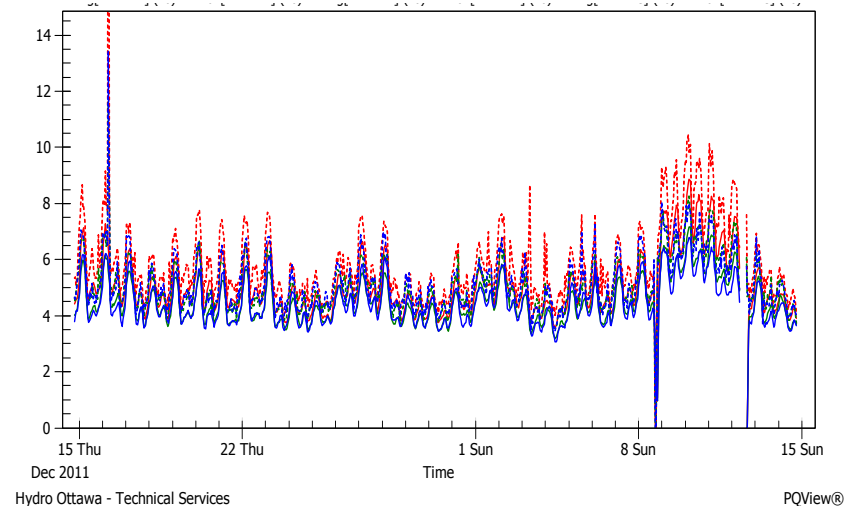
# Current THD Trends

Current THD did clearly identify an anomaly on T1 & T2 but it would be challenging to setup a threshold to capture a possible failure before significant damage occurred.

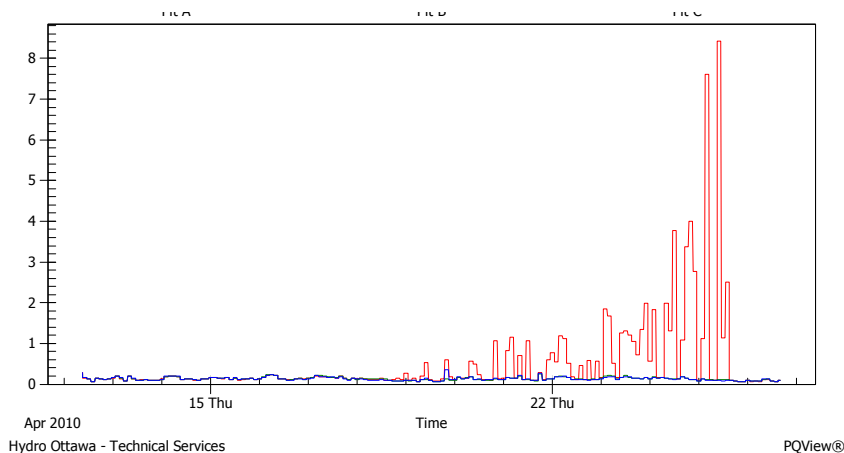
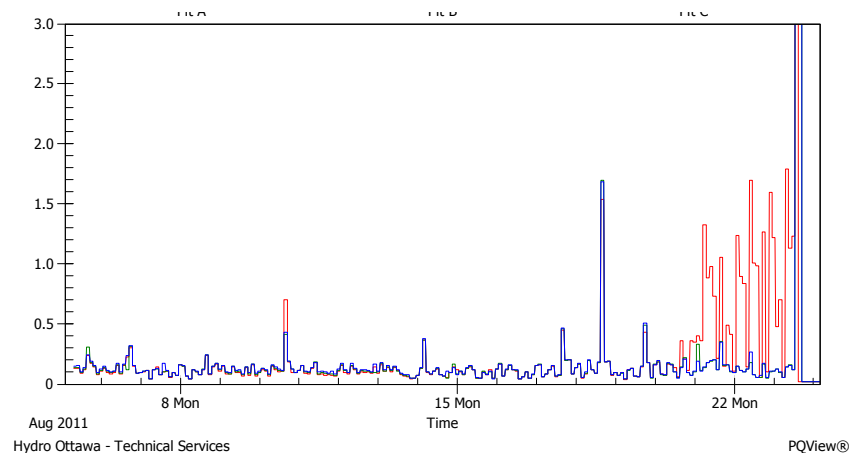
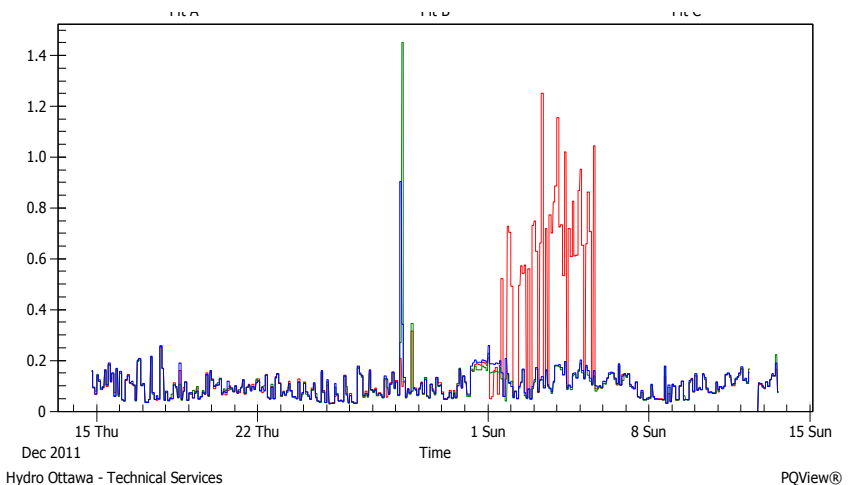
# Voltage PLT Flicker Trends

PST and PLT flicker data identified the start of the **serious** damage to the tapchanger within hours on all three transformers.

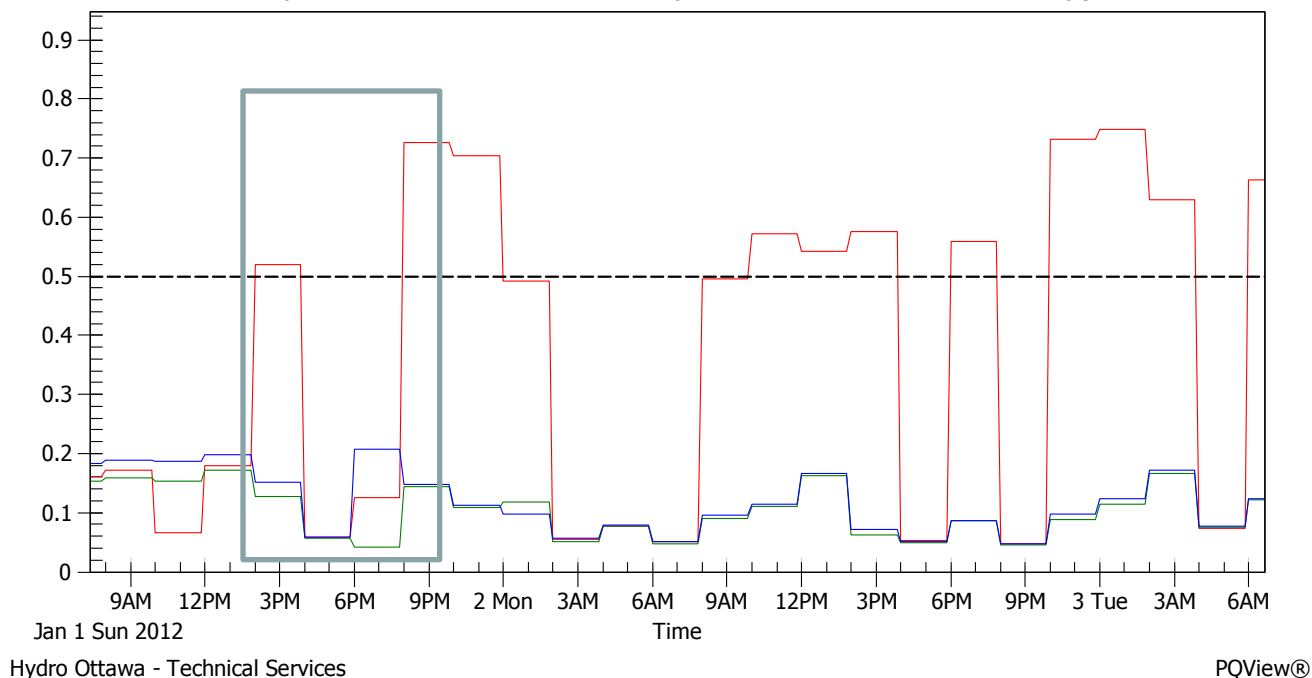
# Voltage PLT Analysis Tool

- 0.5% Voltage PLT threshold
- 3-hour limit above threshold in 24 hour sliding window.
- Email notification would have gone out on Jan 1 at 9:00 PM indicating a possible problem with transformer and it should be investigated.

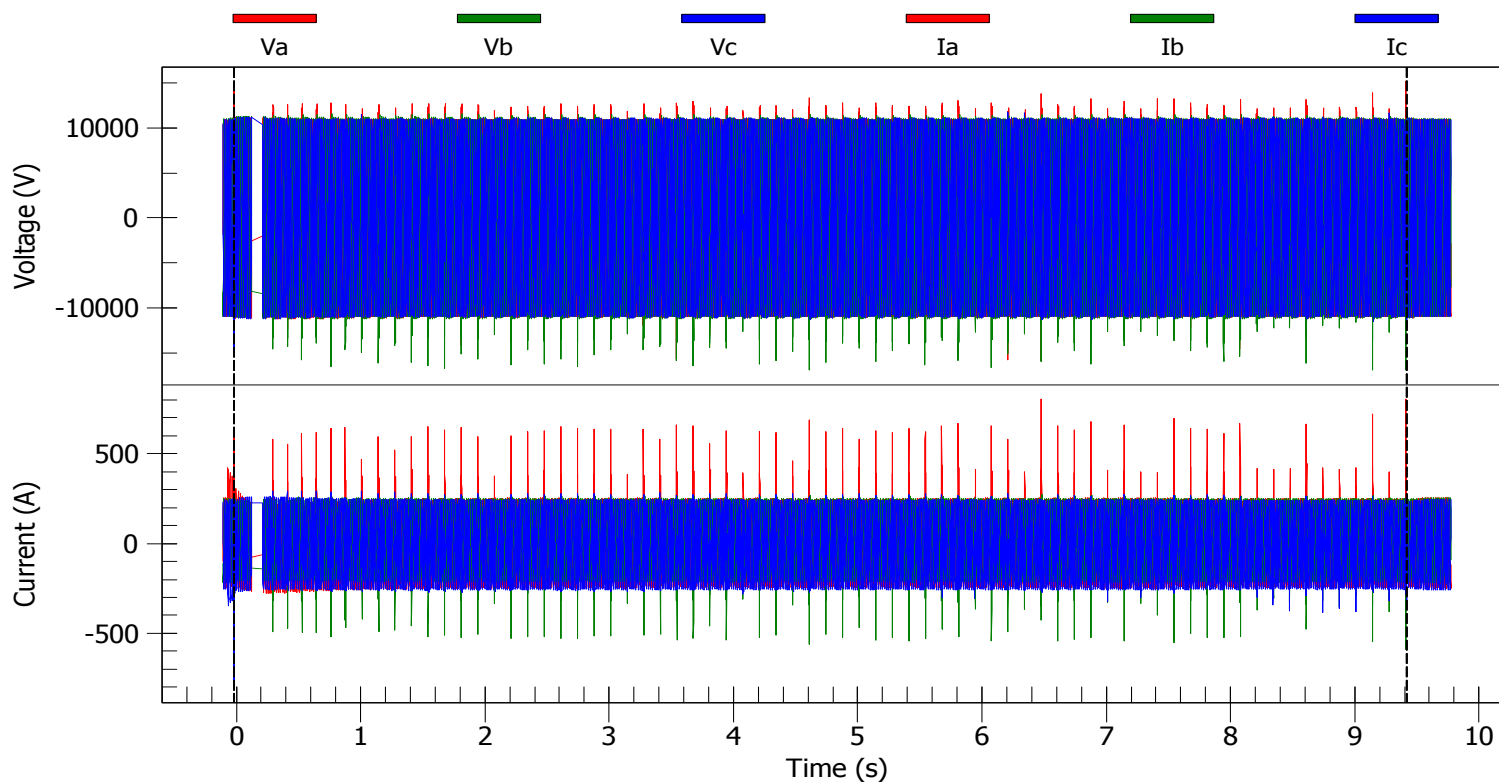
# Failed Operation of New Capacitor Bank

The Capacitor Bank energized and de-energized seventy times in ten seconds. Engineering staff and control manufacturer believed this could not happen and the meter was erroneous.

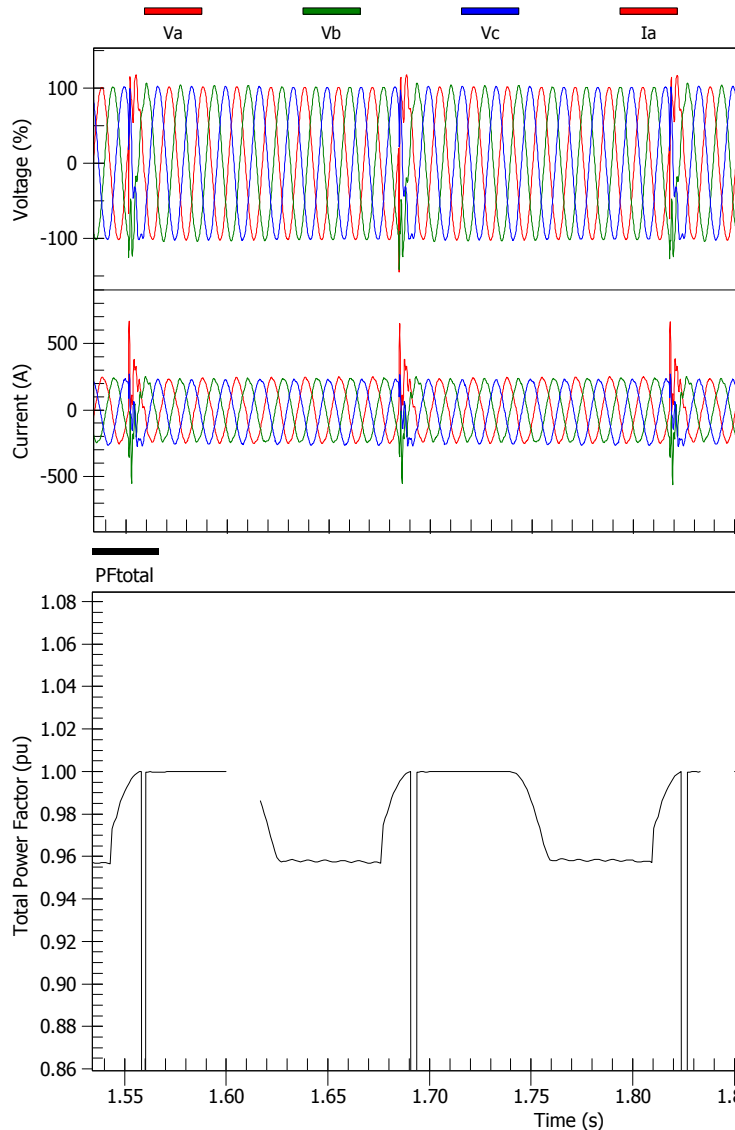
# Failed Operation of New Capacitor Bank Confirmed

In this substation, both buses are in parallel and both ION meters saw the same event and SCADA told us the breaker operated a number of times

The graph below is shows the power factor is fluctuating between events and leading for a few cycles after the event and then dropping back to 0.96

Our engineering staff and the manufacturer are now investigating further to determine the cause

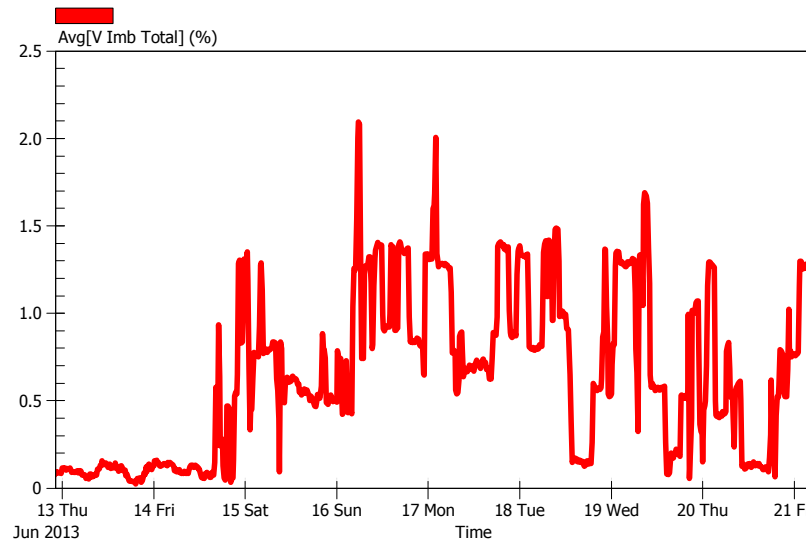
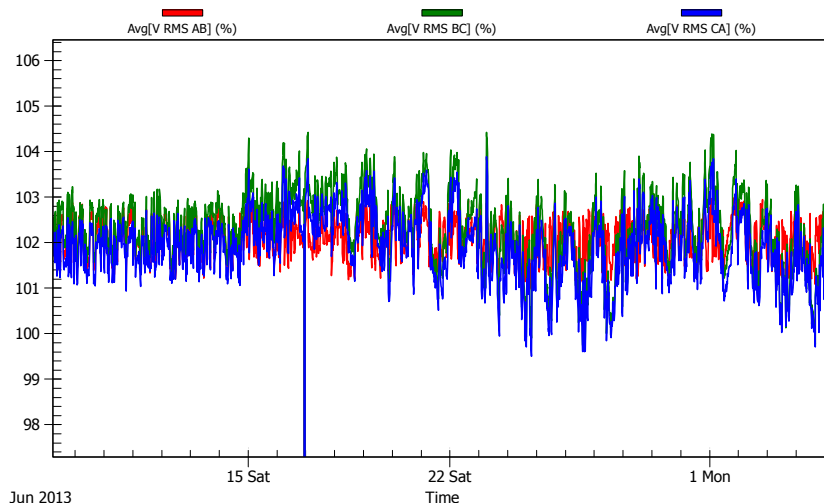
# Transformer Voltage Imbalance Problem

In June this year, a substation ION started to indicate increased voltage imbalance on a transformer bus.

The phase-to-phase voltage graph below did not indicate anything significantly abnormal

Problem was a broken chain on one phase in a tap-changer only allowing two phases to be regulated and the over fluctuated with the 115kV supply

**Recommendation: Setup 3 phase- 4 wire wye ION meters to measure phase-to-neutral voltages rather than phase-to-phase. This can be done after a meter is locked and sealed as well.**

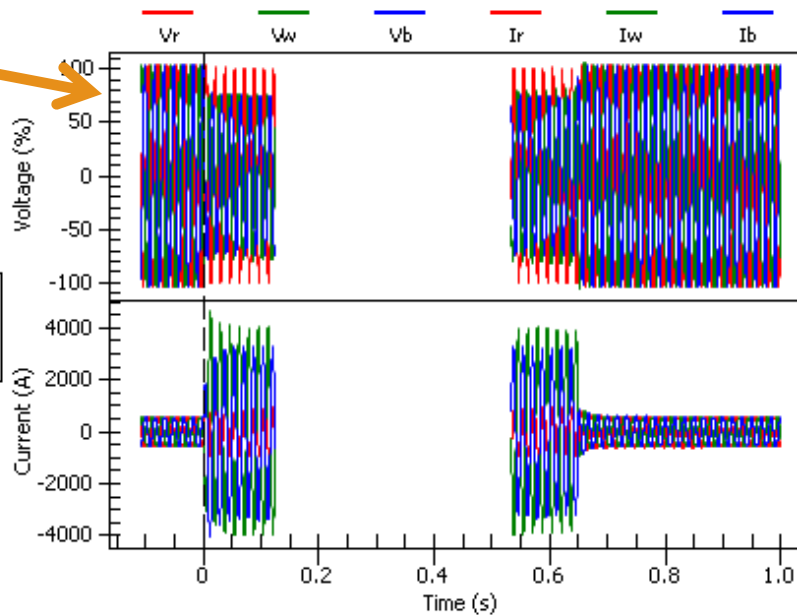
# Integrated with SCADA PI Historian to correlate breaker events with PQView event captures

Sag event captured by ION meter

Breaker Operation imported from SCADA

22M27 auto-reclosed. Heavy snow squall in the area.

Event Cause added and available to all users and characteristics added for future analysis

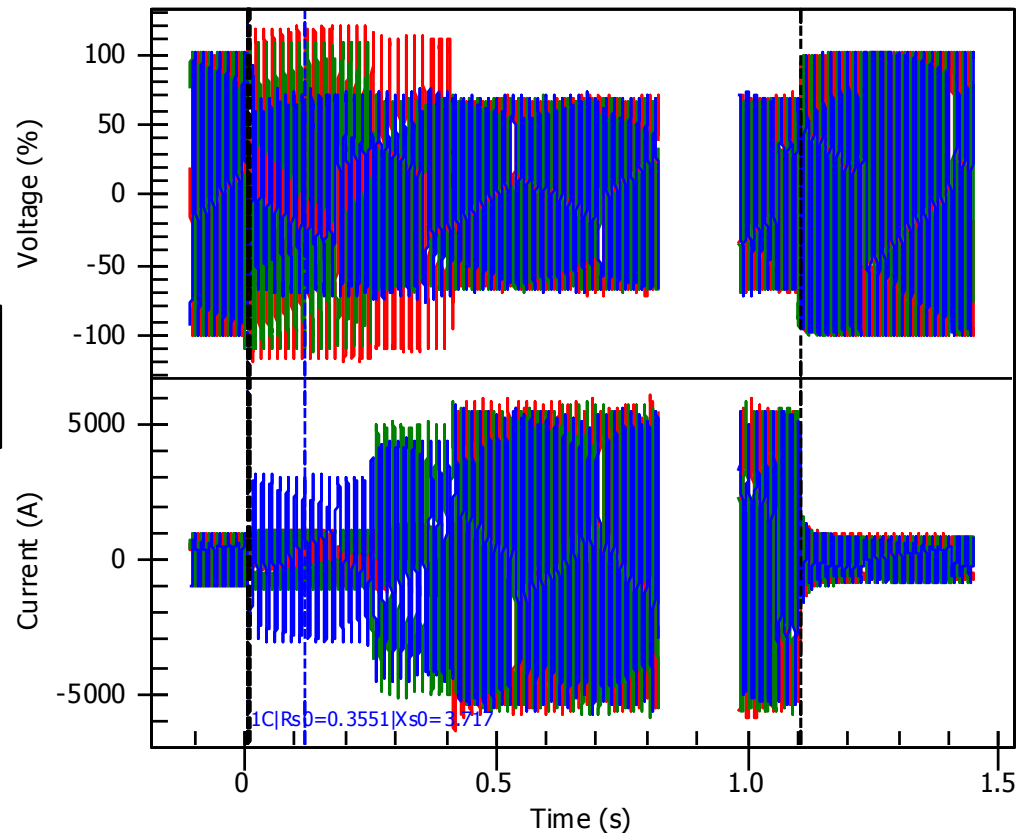
HO\_Overbrooke.T1\_J2 - 10/7/2013 11:49:38.6471

Duration: 1.099s

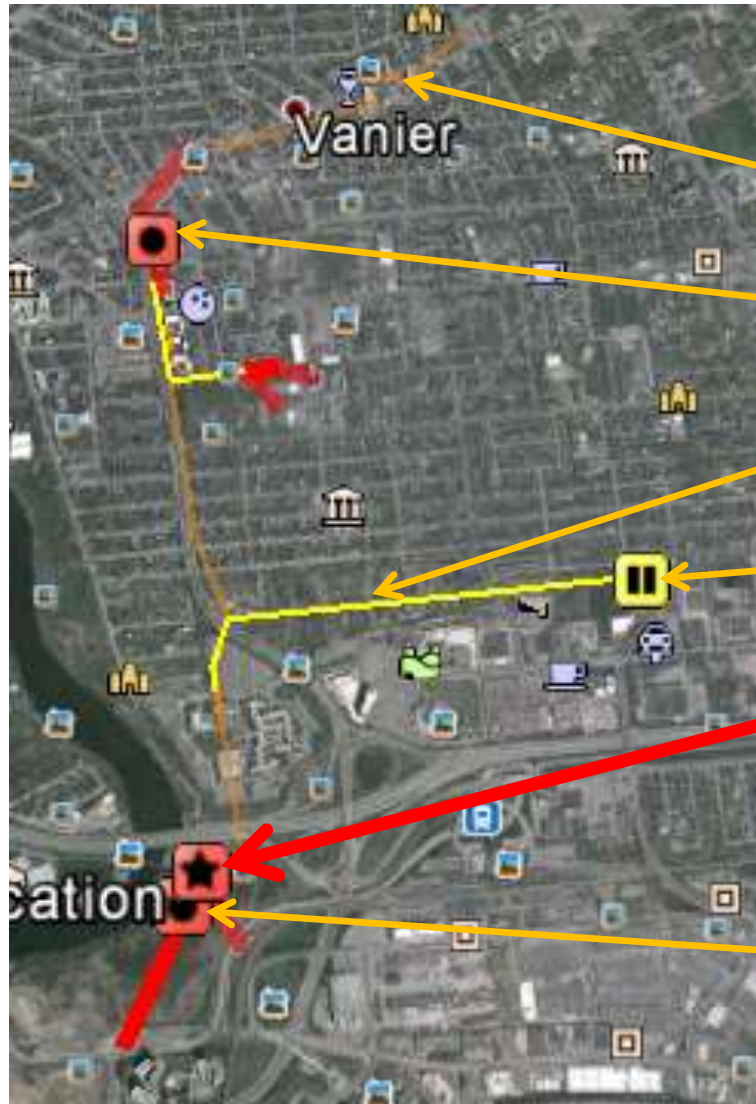
# Using PQView and CYME for Fault Locating

Orange line is UG cable

Predicted fault locations

Yellow line is overhead section

**ACTUAL FAULT LOCATION**

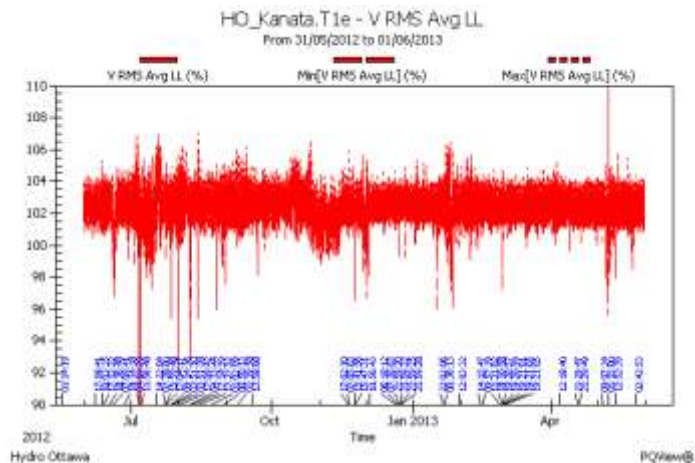
Trend Chart with Hyperlinks to PQ Events

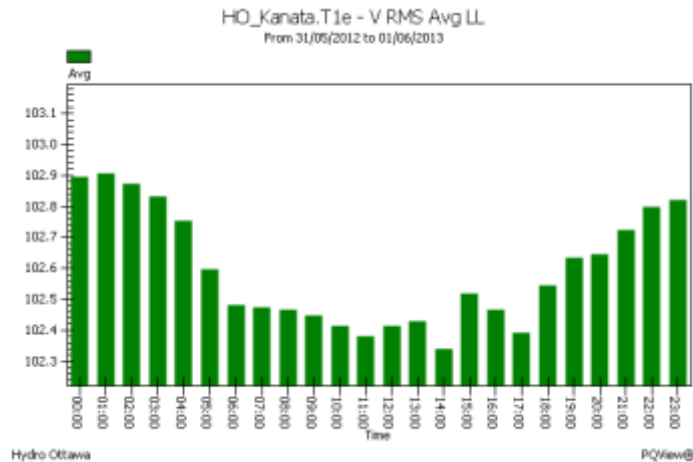
Profile Charts (this example is hourly)

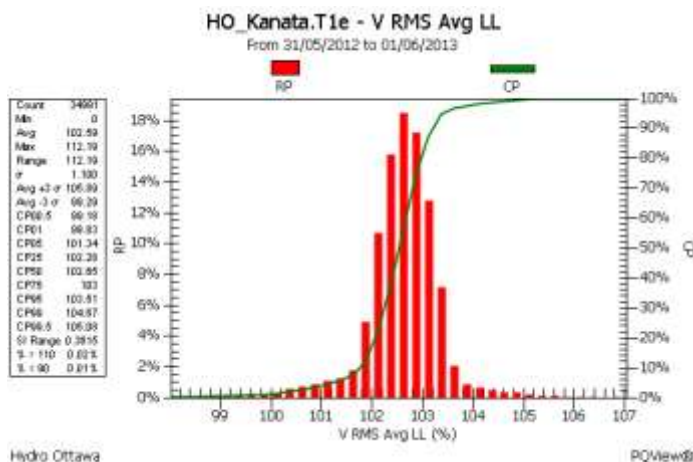
Histogram Chart with Statistics

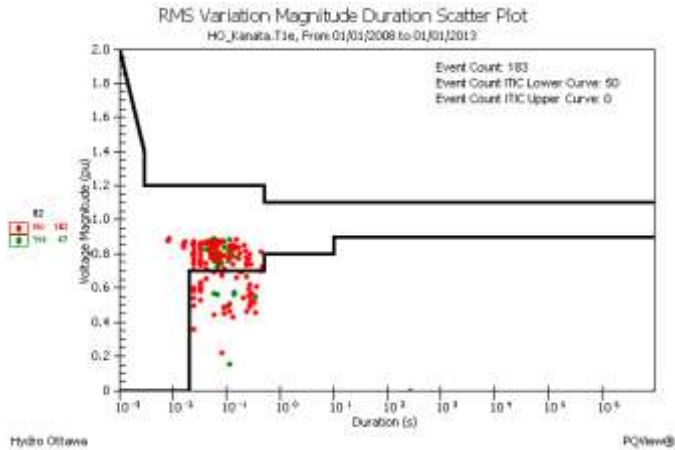
Events plotted on ITIC Chart

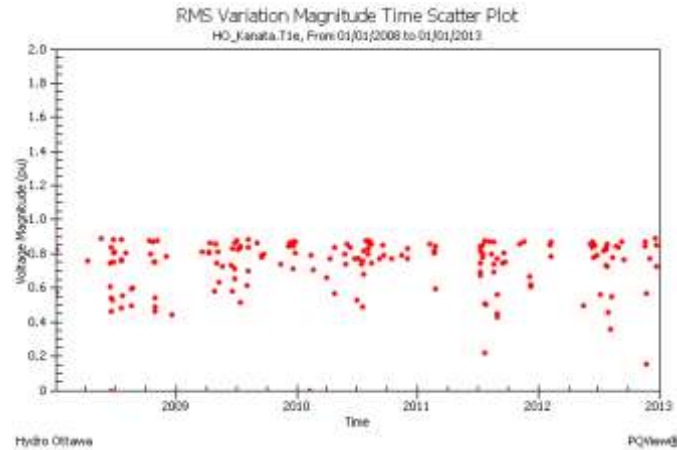
Events plotted on Time Scatter graph

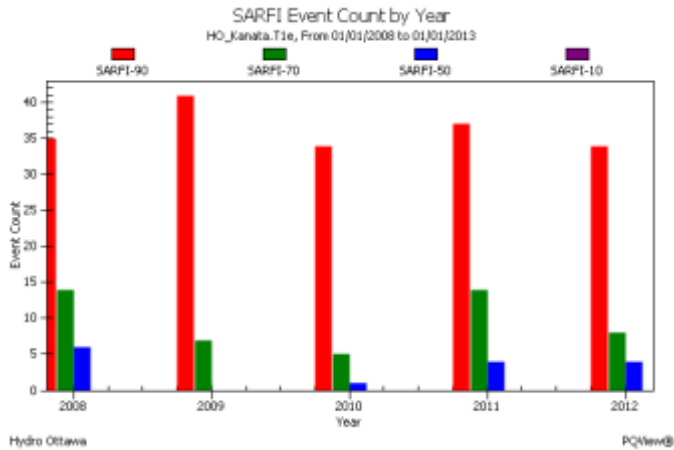
SARFI Event Count

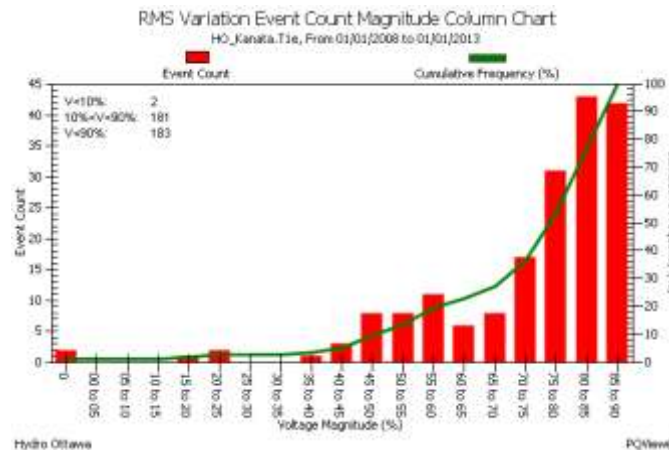
Sag Magnitude Column Chart

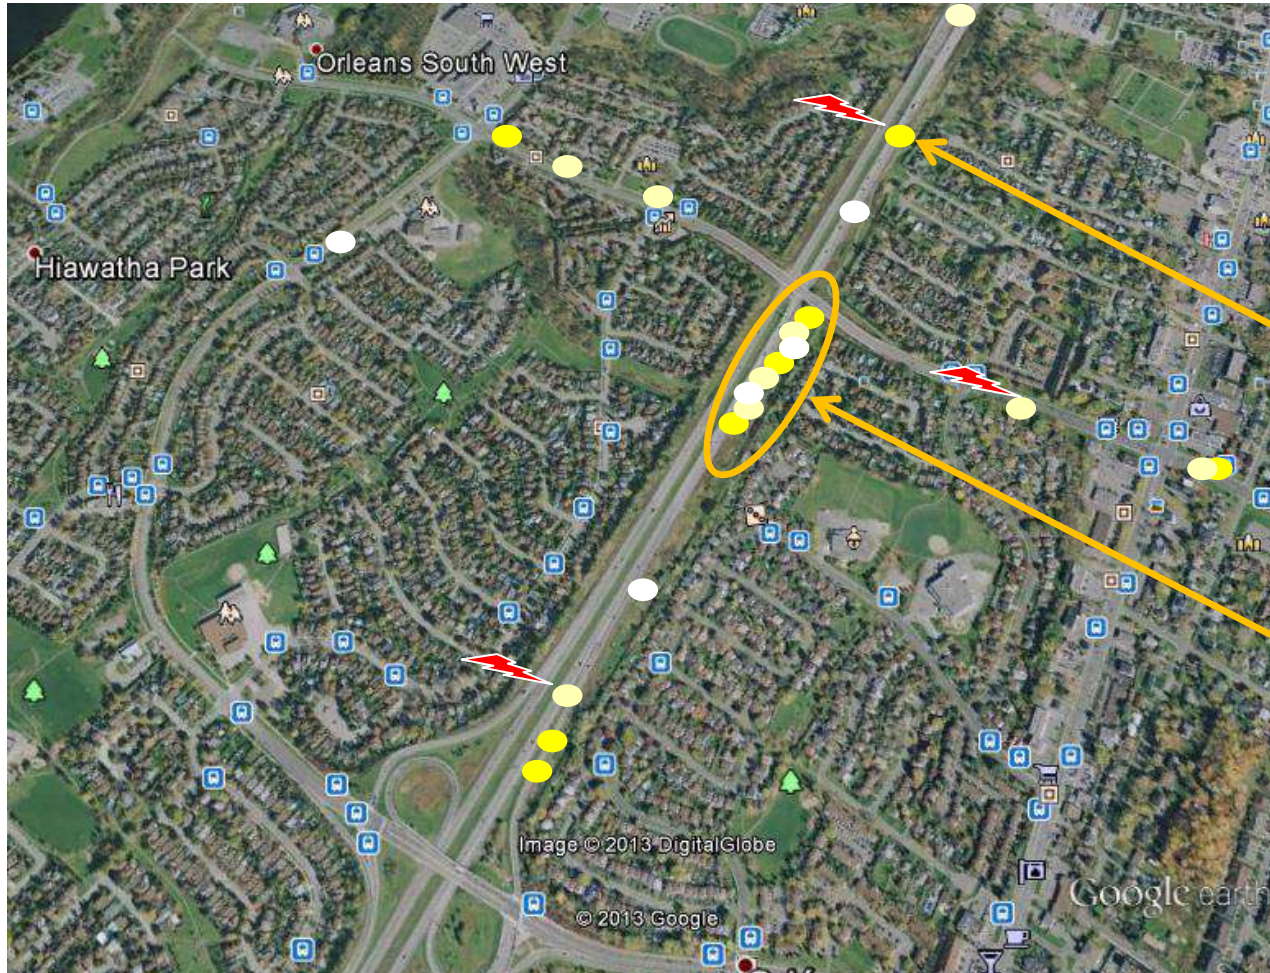
# Using Big Data...

Fault locations shaded by age. Brightest are the most recent

Recent lightning strike correlates with known fault location and auto-relocate

Rash of events in same area  
Trees?  
Bad insulators?  
Large population of squirrels?
