Hardening Communications Infrastructure to Reduce MTR's and Improve Reliability

Oct 19, 2017

Ted Villemaire

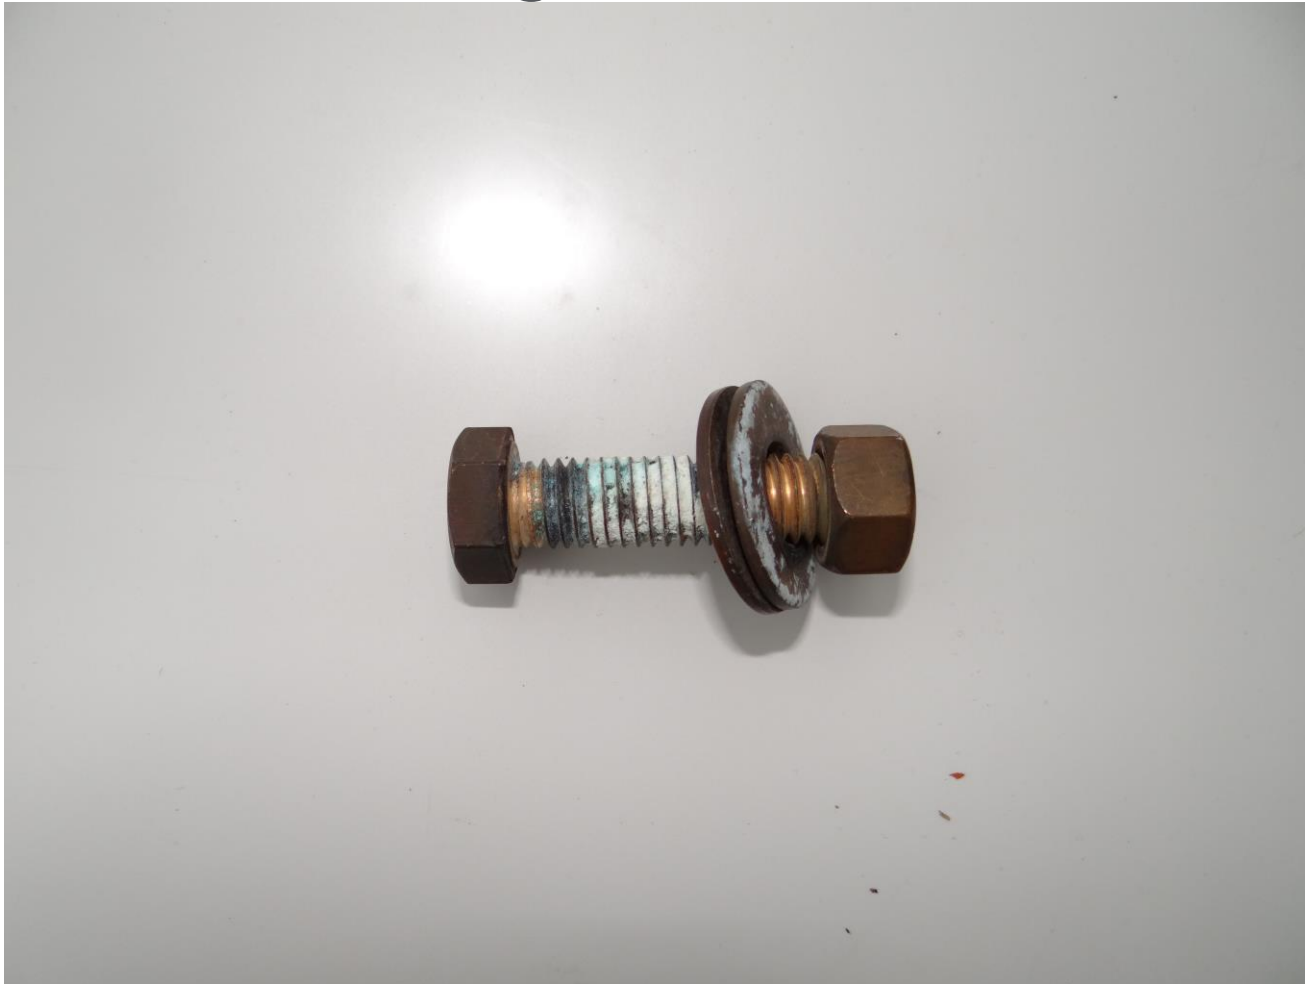
Oxidation-Lug Bolt

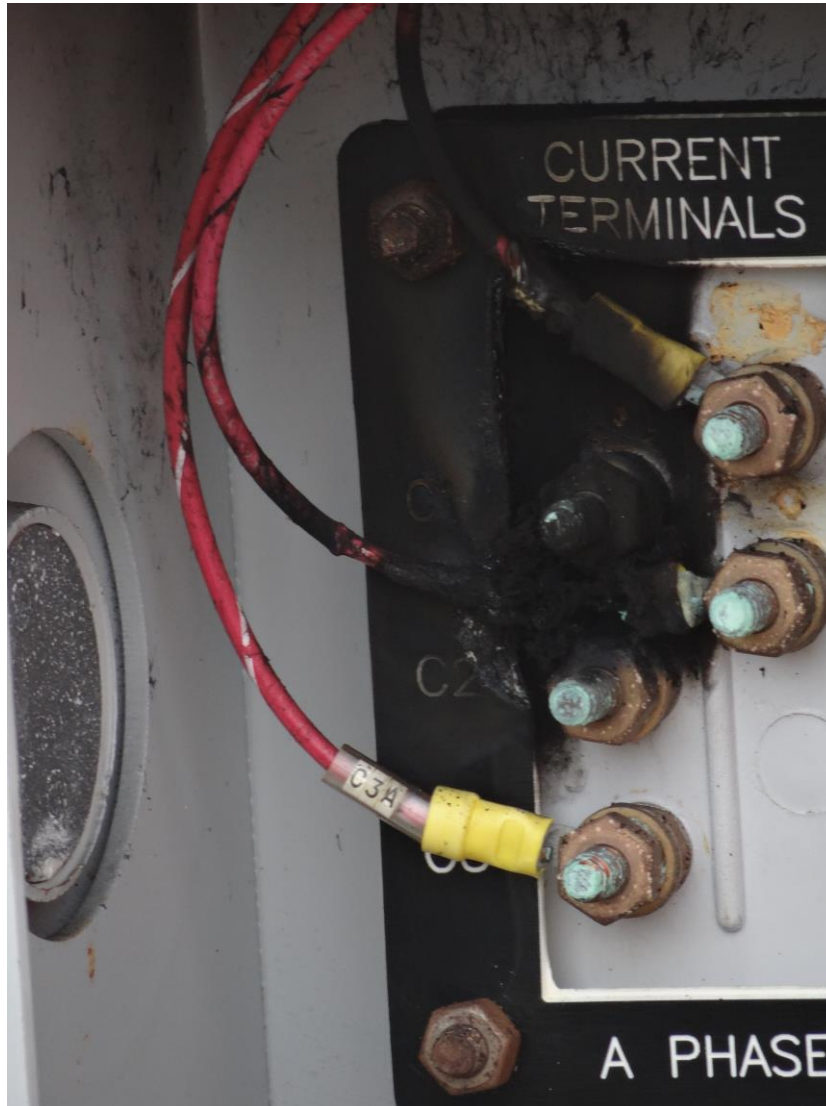
Surge – CT

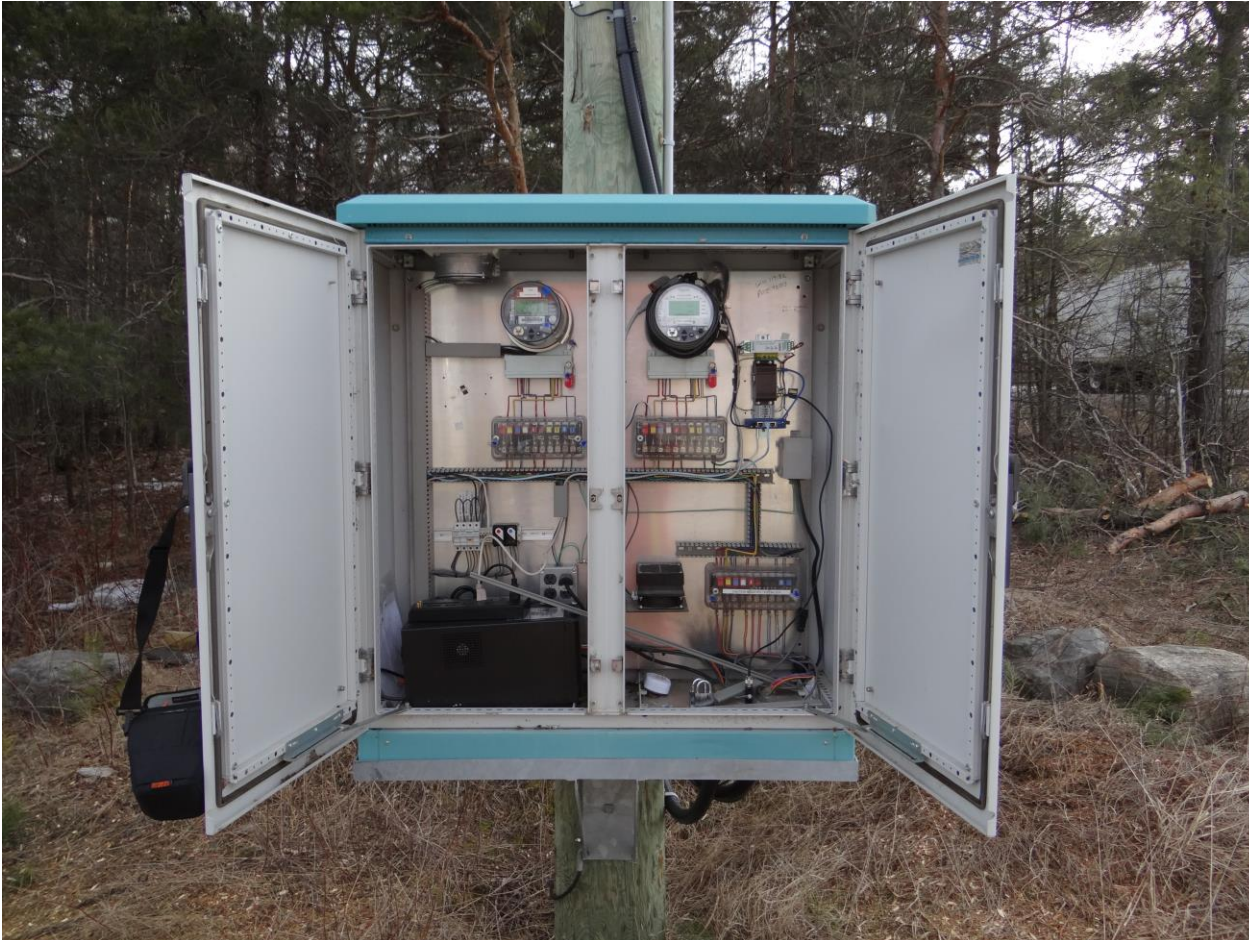
Surge - Backplate

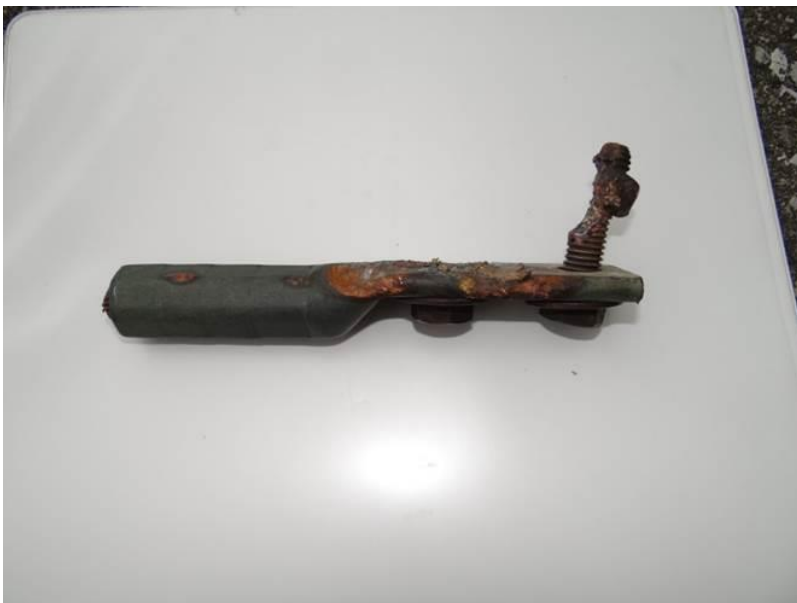
Thermal Problem Detail Report

Severity: 1

Location: Vaughan Underground Distribution \ Primary Metering \ #5869 Hwy #7 (~600m W/O Martingrove Rd.)

Description: Blue phase conductor ground lug bolted connection at ground bar

Probable Cause: High-resistance ground connection. High bleeder current.

Recommendation: Remake ground connections. Check ground currents.
